Standard Building Inspection Report

For Jan Hixsmith at 2929 Your Ave, Jacksonville, FL

All Pro Home Inspectors Inc

Report Number: HIX111805AP

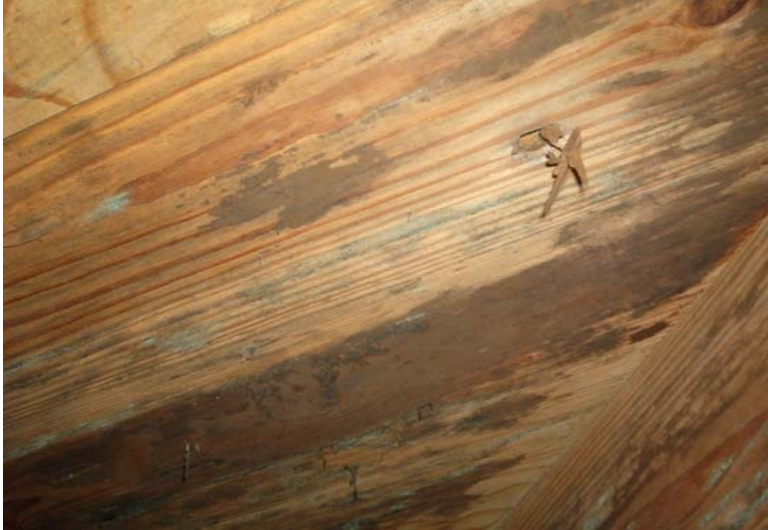
Crawl space flooring & joist appear to have mold/fungus on them.
Advise further evaluation.

141. Mold/fungus

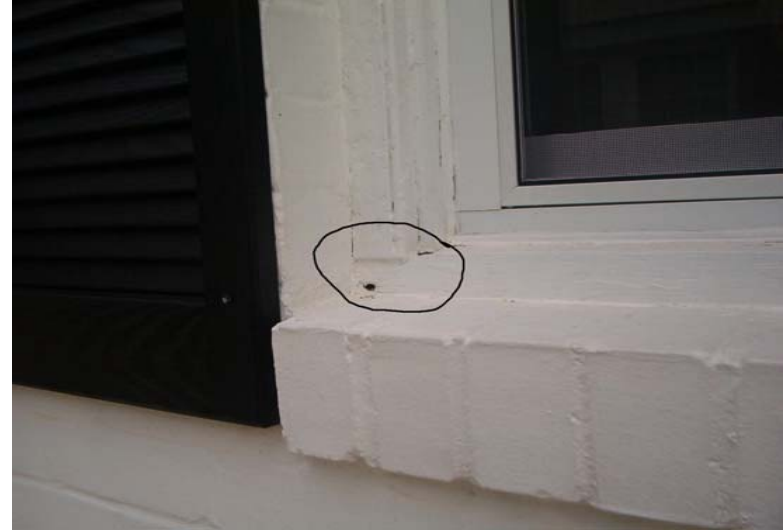
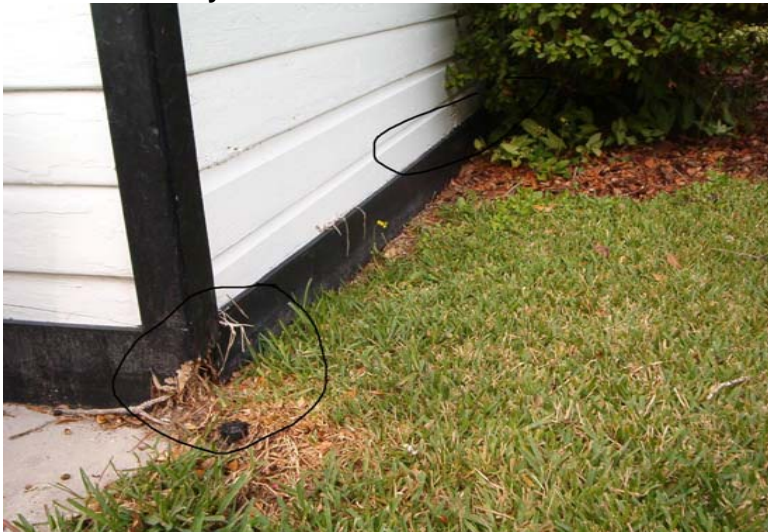
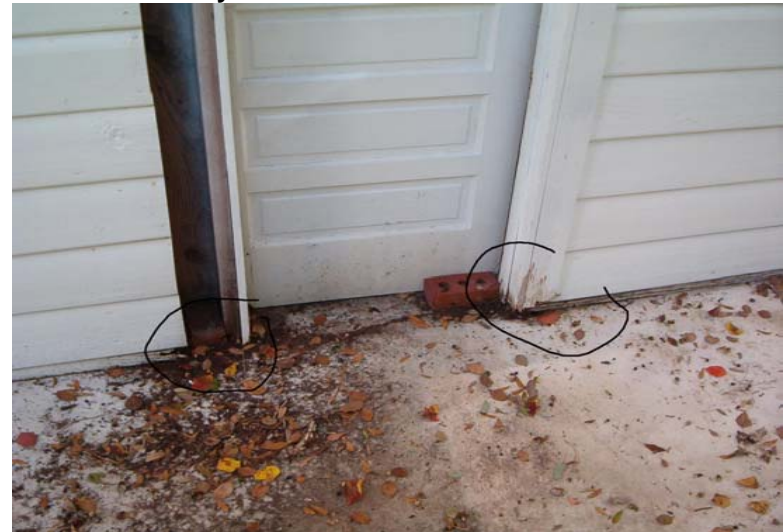
Window sill at first kitchen window . Siding at bottom edge of garage sides & back. Back garage door jambs.

213. Wood Decay / Rot

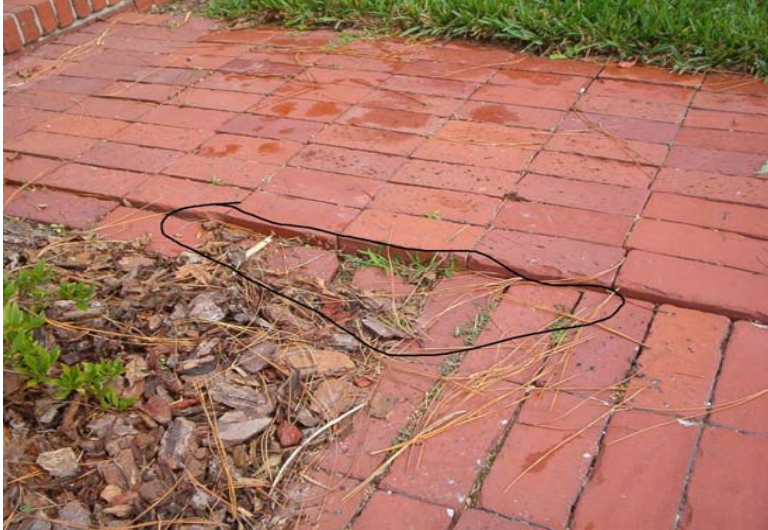
Sidewalk settling at front door.

228. Trip Hazard(s) Noted

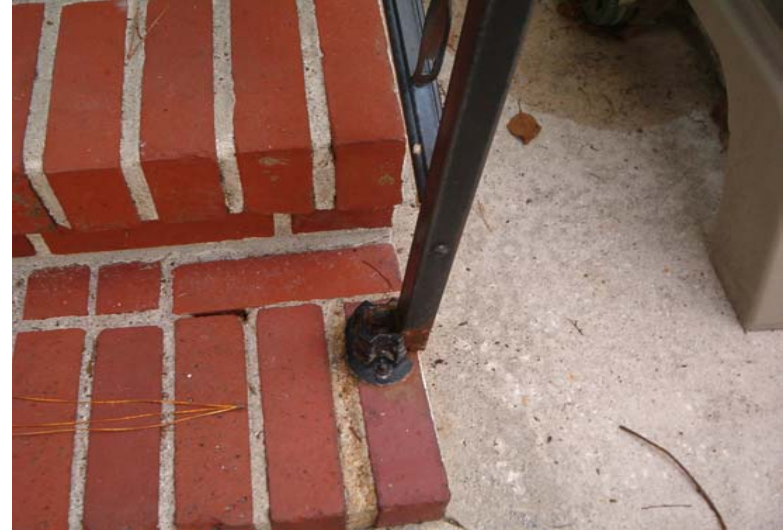
Hand rail loose. Secure.

233. Step railing loose.

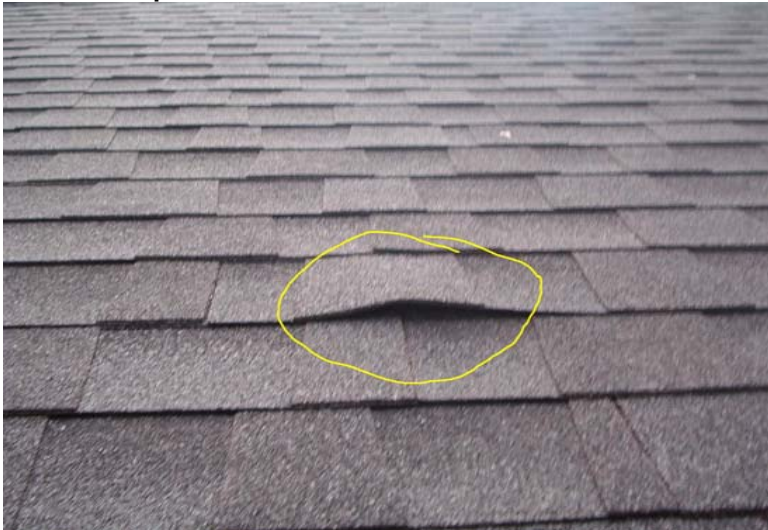
Nail pop located at back side above back door.

311. Nail Pops Evident

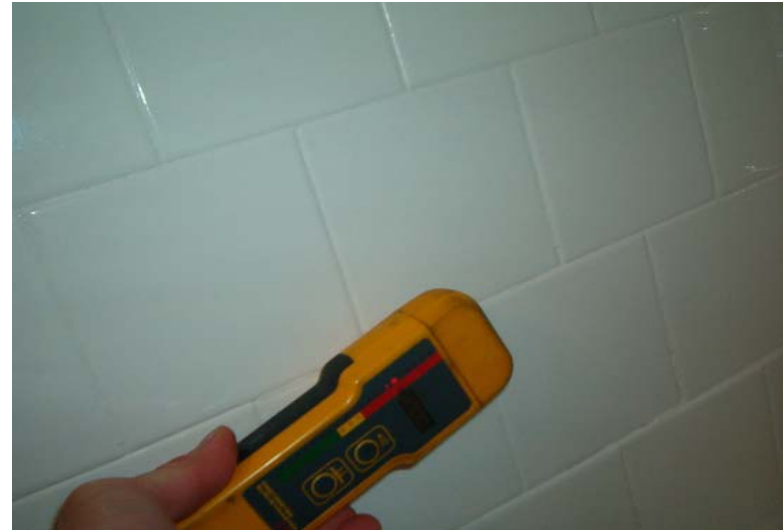
Noted to shower enclosure in Hall bathroom. Left end of shower tiles appear to be loose. High moisture reading also recorded. Budget possible re-tile. Review by tile contractor/plumber advised.

423. Loose Tile

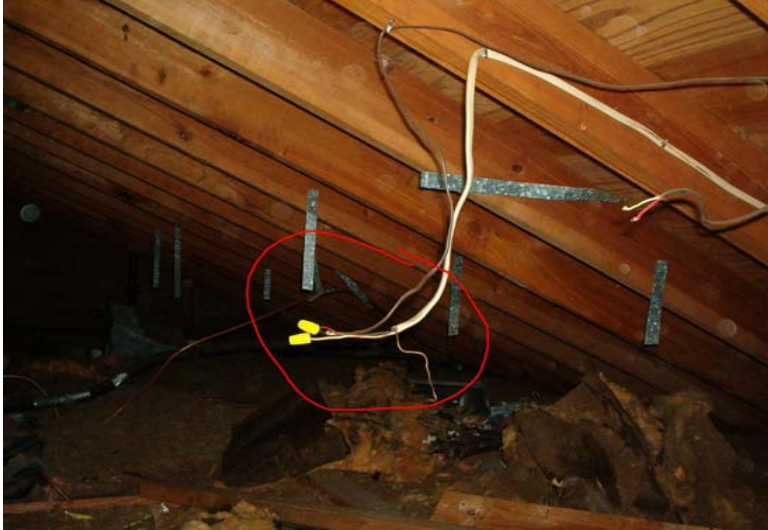
Noted within the attic at various locations. Typically identifies homeowner alterations. Non-standard. Check historical data with seller.

535. Wire Splices Not in Junction Box
